Lower Owyhee Watershed Assessment

XII. Channel Modification

XII. Channel modification assessment

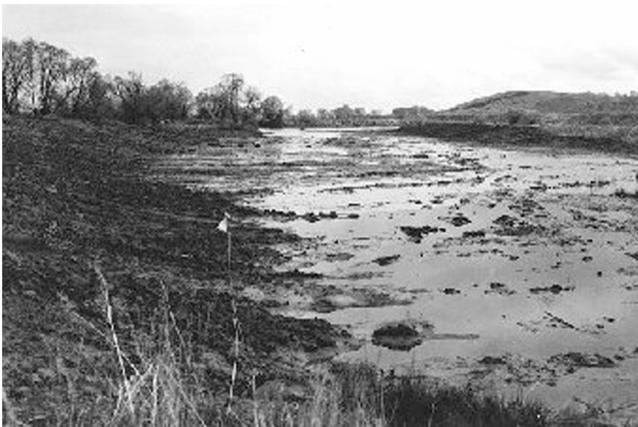
A berm and access road reconstructed across the entrance to the old Owyhee slough. It washed out repeatedly until the 1960s.

Until the 1960s, there was an island where the Owyhee River joined the Snake River. The Owyhee River was on the north side and the old Owyhee slough (Keck slough) was on the south side of the island (Figures 12.1, 12.2, and 12.3). During high water, the river would split and run on both sides of the island.⁸ There was a road across the slough. It washed out repeatedly, so about 1964 the Nyssa road department built a levee for the road to cross. The new road was six to eight feet higher than the old road. Subsequently the river has never breached the levee or run over it (Figures 12.2 and 12.3).⁴

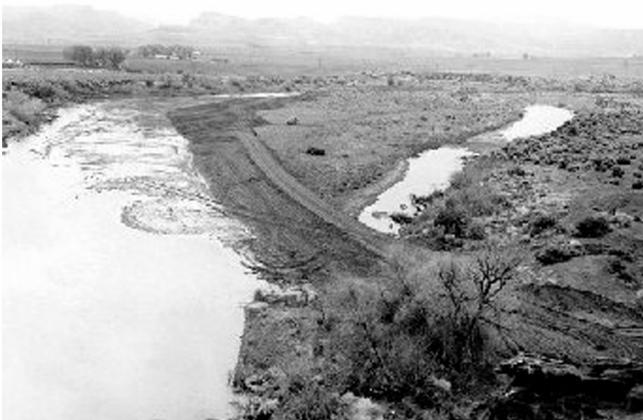
Bull dozers were used to scrape vegetation out of the river and off the banks.

Following the flooding of 1952, work was done on the Owyhee River channel below the dam between October 1953 and May 1954. During 1953 the Army Corps of Engineers prepared plans and specifications for "clearing and snagging" of the Owyhee River and began clearing the river bed (Figure 12.1). The actual channel clearing and snagging was completed in 1954. Four heavy bulldozers worked in the lower 12 miles of the Owyhee River from the junction with the Snake River upstream. Silt and brush were cleared in about eight miles of the channel (Figure 12.1).^{5,9,10} A resident remembers that the army corps cleaned out parts of the main channel (Figure 12.1) and built a couple of berms to protect the channel but they "really did very little."⁸

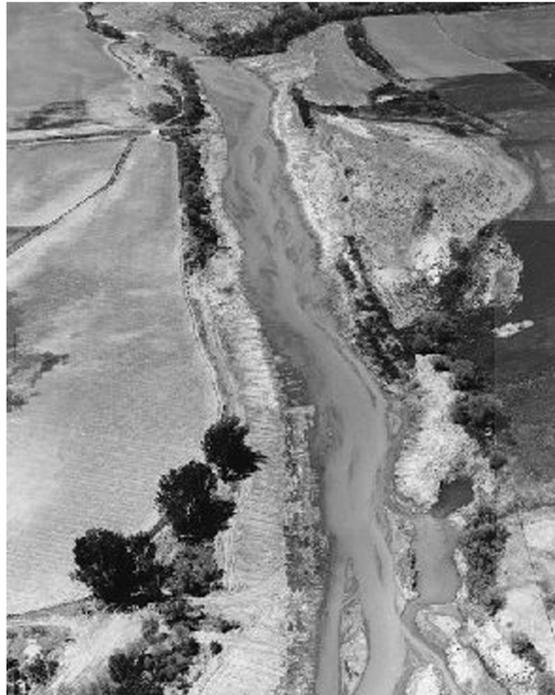
Figure 12.1. Army Corps of Engineers clearing and snagging of the Owyhee River below Owyhee Dam, 1954.

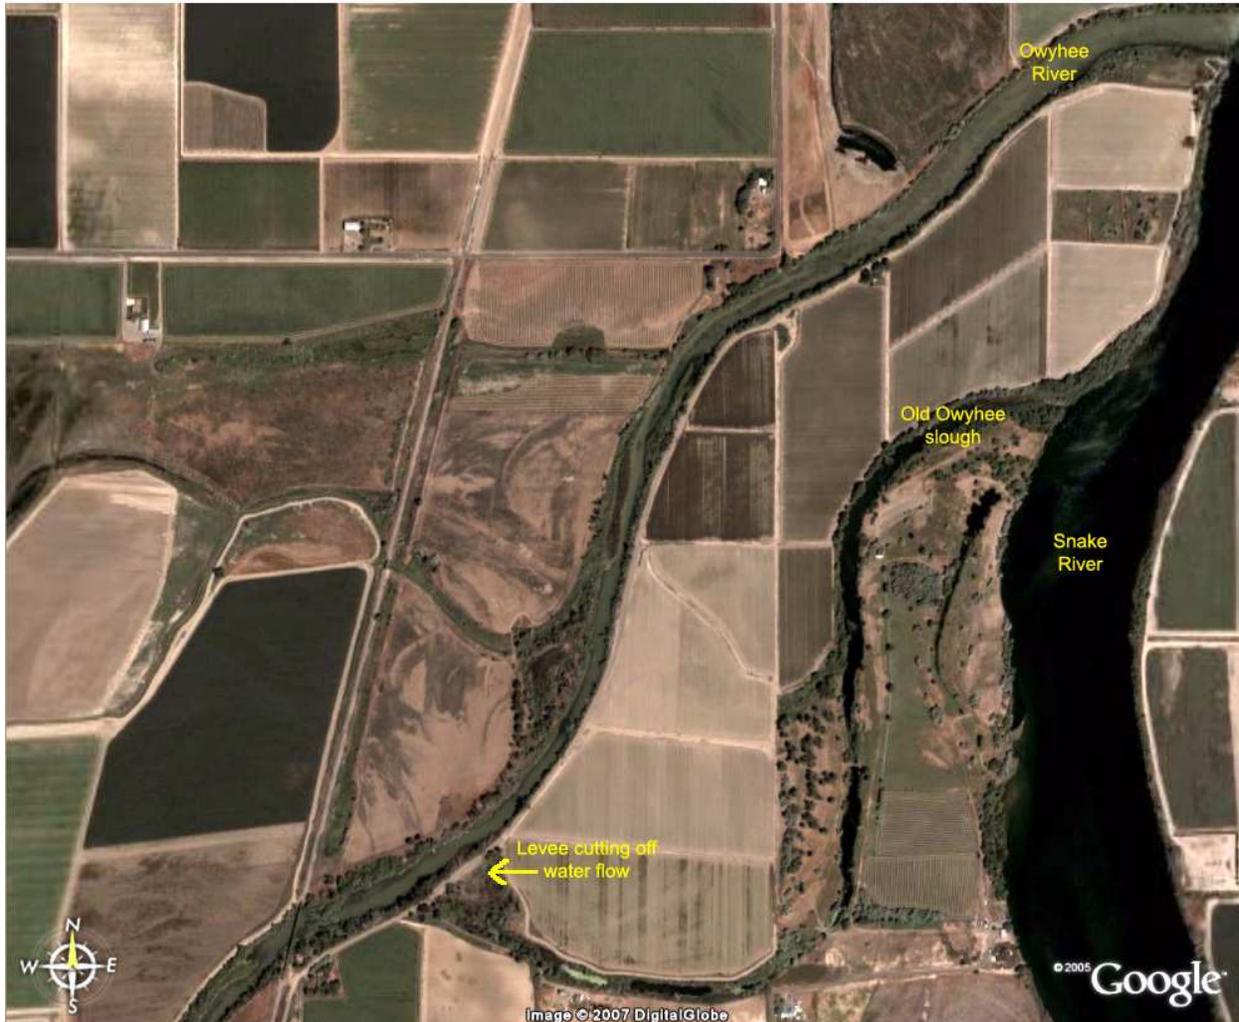
Figure 12.2. Aerial view of the route of the old Owyhee slough.

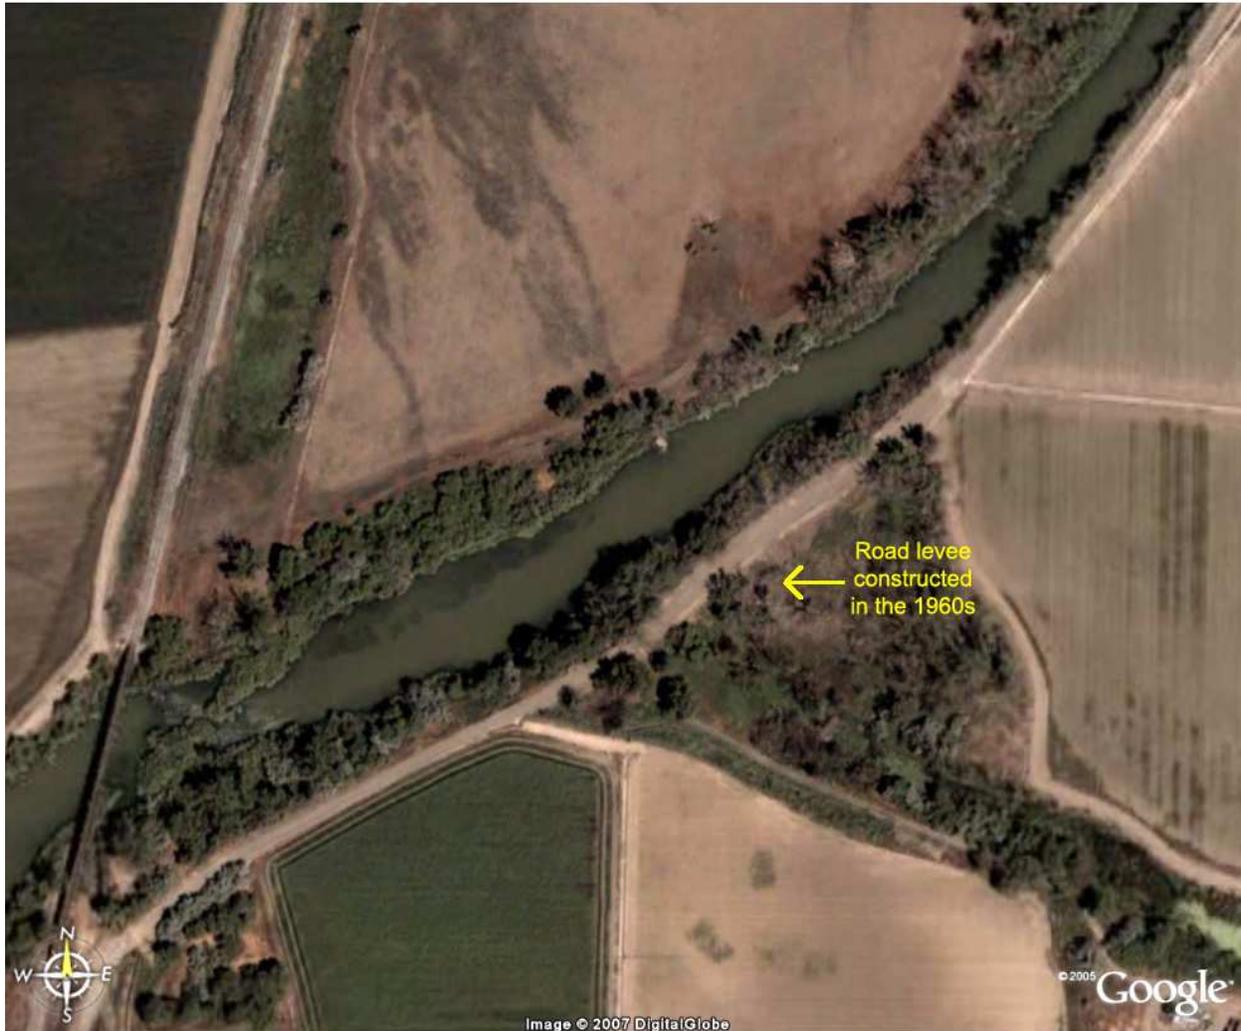
Figure 12.3. Aerial view of the road construction which cut off water flow into the old Owyhee slough.
